# CROXDEN ABBEY STAFFORDSHIRE

## CROXDEN ABBEY AND ITS ENVIRONS

#### **SUMMARY**

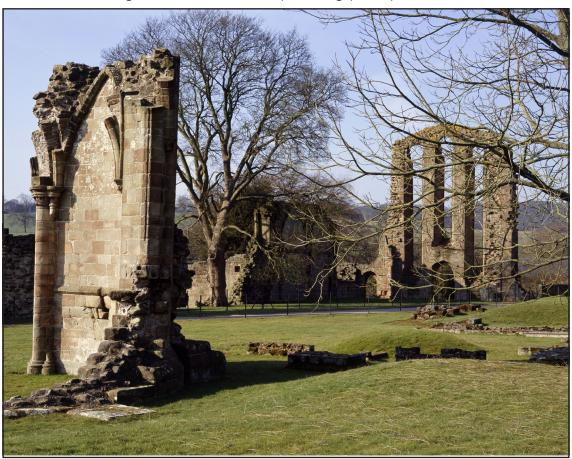
Figure 3. The imposing west front of the monastic church can be seen in the distance. In the foreground are the fragmentary remains of an apsidal chapel in the east end of the church

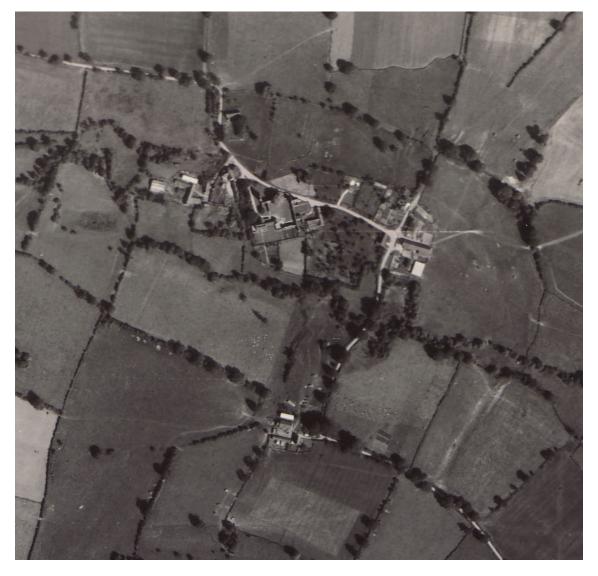
Figure 14. Aerial photograph of the precinct showing the boundary bank on the eastern (lower right) side (NMR: RAF 1553 dated 1 Sep 54, No 0162. © Crown Copyright NMR).

Further south from (b) a deep cutting slices through the precinct. On the southern side of the cutting the course of the boundary lies along a dam. Here there is evidence of the fragmentary remains of walling. The course of the wall continues south to the field boundary and then turns east-south-east. Thick hedging along the southern side masks the full extent of the wall although in the western corner stonework has been levelled by cattle. In the south-eastern corner there is the remains of stone walling at the field gate. East of this, in Bigg Smithy Croft, a prominent scarp up to 1m high and surmounted by a hedge marks the course of the precinct wall as far as the south-eastern corner of the field. In places a berm separates the scarp from the course of the wall. Further east its course is unclear although it probably continues as a spread scarp to the road (c). On the southern side of Bigg Smithy Croft Lynam's plan shows a track to Hollington which probably also continued to Great Gate (Lynam 1911). The eastern side of the road was not surveyed since it is cultivated and there is no evidence of earthworks. However, the road eastwards is embanked, which again probably marks the course of the precinct. The south-eastern side of the precinct boundary is shown as a linear crop-mark on aerial photographs and extends northwards to Croxden Brook (Fig. 14).

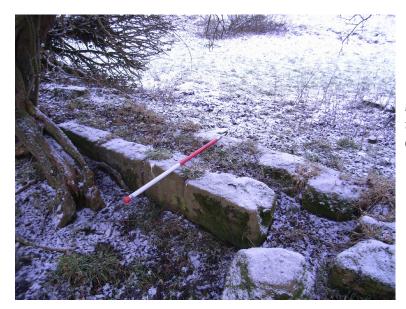
Figure 15. Footings of the precinct wall in Coney Greaves Field.

slight gap measuring c 0.6m wide overall (Fig 15). More substantial re-built walling is also evident as far as the junction with the road to the north of St Giles's Church.

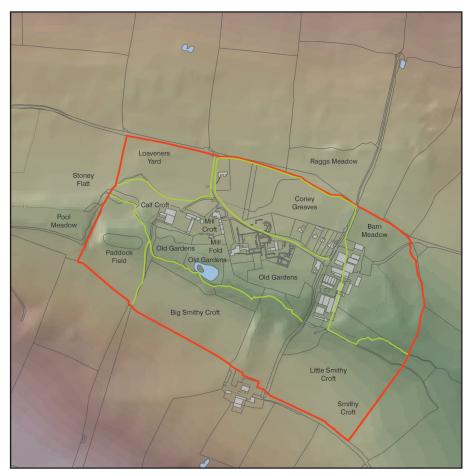
Figure 16. Field names from the 1722 estate map.

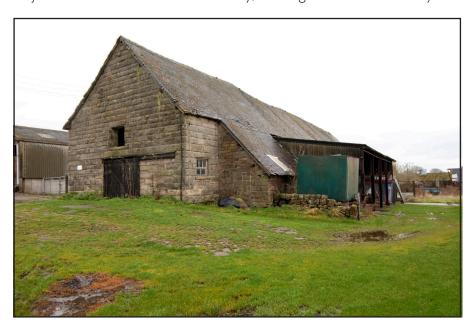
Figure 24. The barn viewed from the south-west (NMR: DP085586, © English Heritage)

The barn is aligned approximately east to west, with the earlier part of the building located to the west, nearest the abbey ruins. Neither end of the original barn survives, but its original extent can be surmised from other evidence, and it is likely that the present footprint is close to the original, notwithstanding the possibility that aisles may have been removed. The remains of early, but perhaps not medieval, stonework embedded internally in the east wall, indicates that this is on the alignment of an early if not original east end. Carpenters' marks on the tie-beams and queen struts identify the western truss as 'I', while the surviving original roof bay to its west indicates that this is the first internal truss, positioned one-bay in from the west end wall. This would mean that the present west wall corresponds with the original. Trusses 'I', 'III', 'III' and 'IIII' are marked in sequence from west to east. The fifth truss, to the east, is marked with a 'I' or a half score mark, but this is less readily discernible. This truss has redundant pegs and windbrace seatings for a further bay to the east, therefore denoting that the barn was at least six bays long.

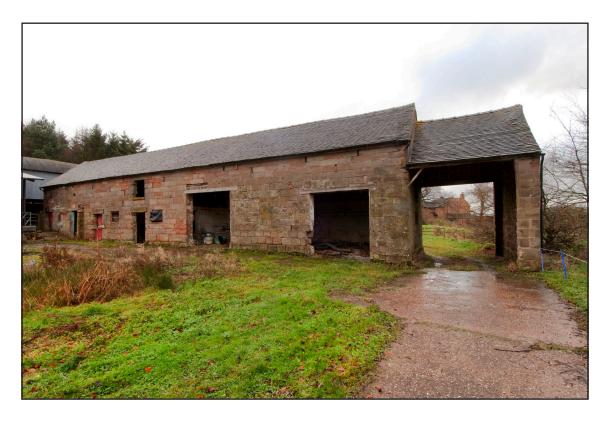
Figure 26. Barn to the west of the abbey ruins, viewed from the west (NMR: DP085579, © English Heritage)..

The earlier stonework is found in the south, east and west walls, all towards the southern end of the building (excluding an added cart drive abutting the south end), and indicates that three walls of an earlier building were reused in situ. Only the lower sections of the walls survive, except to the south where the earlier end wall is slightly taller. The stonework includes a double plinth with chamfered stone plinth courses, indicative of a substantial building, with high-quality stonework, possibly reused from the abbey ruins in the post-dissolution period. The function of the original building is unclear.

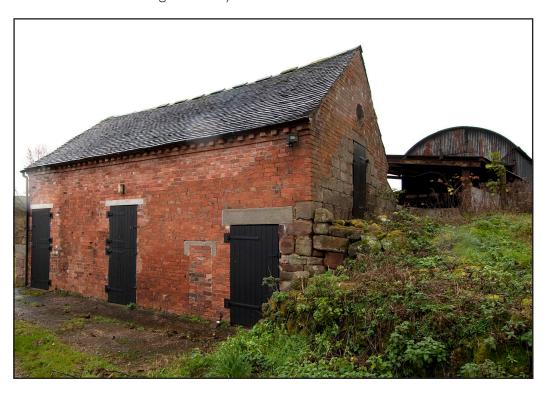
Figure 27. The remains of the farm building and mill viewed from the north-east (NMR: DP085583 © English Heritage)

a complete gable wall fossilised in the present end wall, to the south, along with the truncated stubs of the former side walls. This formed part of a building extending to the south of the present footprint, and which probably functioned as the main mill building, at least during a substantial period of the building's history. Although these early phases are characterised by the use of sandstone-ashlar blocks, similar stonework has been reused as an external facing to brickwork, including stones bearing radial wear grooves characteristic of rubbing caused by the rotation of a waterwheel.

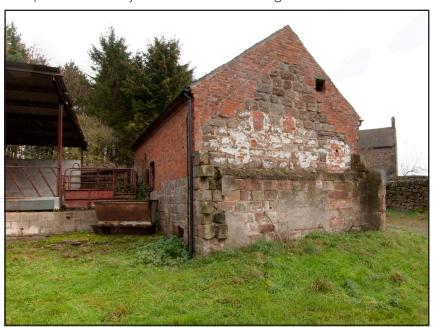
Figure 28. Remains of the farm building and mill viewed from the south (NMR: DP085578 © English Heritage)

The evidence of phasing at the south end of the building is relatively straight-forward. On the west elevation, at the south-west corner of the building, a vertical straight joint is formed where stonework of two phases abuts, close to the present south gable end. The position of the joint indicates that the gable wall was associated with a building

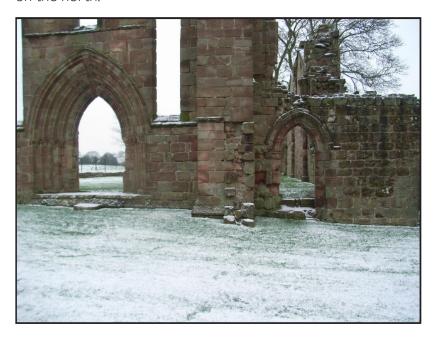
Figure 29. West front of the church showing the position of the wall cut into the south buttress.

During his excavations at Croxden, Lynam recorded the foundations of a wall that extended from the southern buttress of the west front of the church; this wall is shown on two of his plans (Lynam 1911, 3). The wall foundations measure 35m long and c0.5m wide (narrower than the buttress on the church). At its west end it turns north for c1m where it appears to be overlain by a modern outbuilding. The wall stood 2.5m high, the height being reflected in the stonework on the buttress (Fig 29). A narrow doorway on Lynam's plan is positioned at the wall's mid-point with what appears to be two buttresses on the south side on either side of the doorway thus implying that the 'principal' side was on the north.

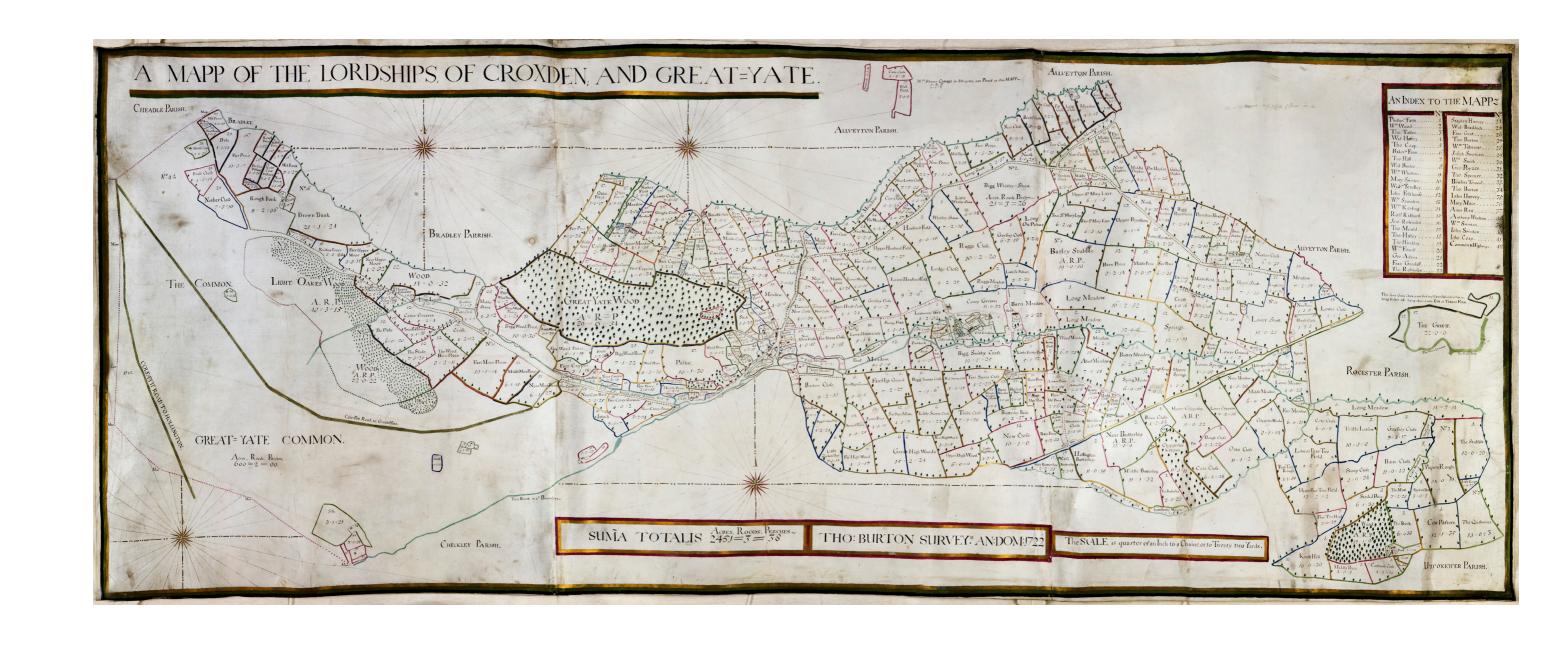
Figure 8. The 1722 estate map of Croxden (Macclesfield Archive)

The surveyed earthworks lie in several modern fields and are contained within the circuit of a fragmentary stone wall, the former precinct boundary (Figs 9 (A3 insert p53), 10). Overall the precinct encompasses an area of about 30ha. The field names used in the report are those shown on the Macclesfield 1722 estate map (Fig 16). Three of the fields, Calf Croft, Mill Croft and Mill Fould contain farm outbuildings and a plantation and were not surveyed. Letters in the report relate to those on the plans.
